# Manhole Inspection Summary

Manhole # S41C2\_018MH

Insp Date: **12/7/07 2:08 PM**

**Location** Address: **3900 10th St**

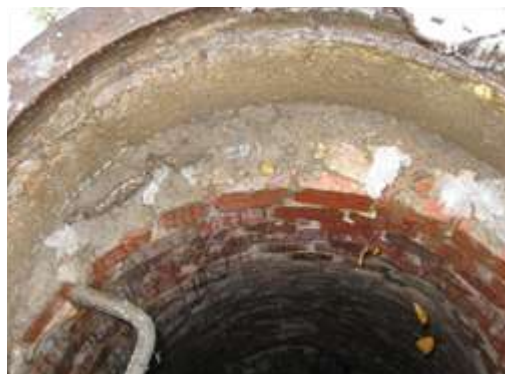
Defect 1

Offset: **5** (in.)

Frame offset

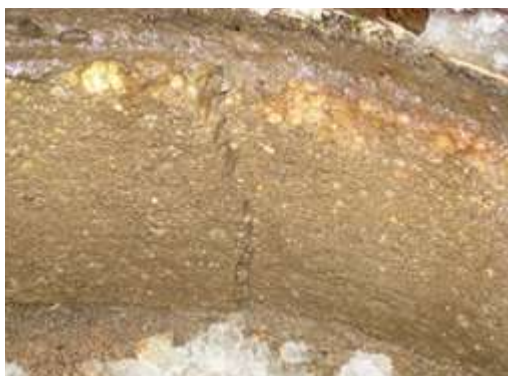
Defect 2

Condition: ☐ Sound ☒ **Cracked** ☐ Leaks

Frame cracked

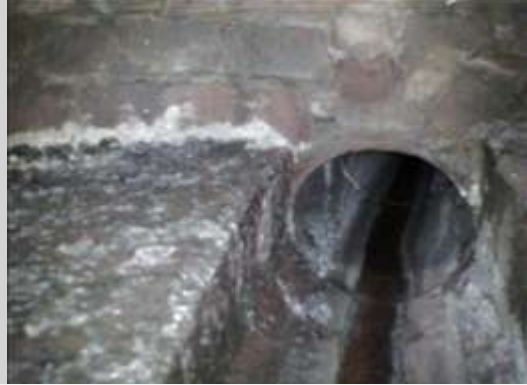
12 O'Clock Outflow

8 in. Circular Gravity Sewer  
Pipe Out @ 12 O'Clock

Pipe Height: **9.6** (in.) Rod and Bar (Angled)  
Pipe Material: **Clay** ☐ Pipe Lined  
Invert Depth: **9.55** (ft.) Flow Characteristics: **Fast**  
Deposits: ☒ None ☐ Mud ☐ Sludge ☐ Debris ☐ Grease  
Silt Depth: (in.) Deposits Extent:  
Infiltration: **None** Pipe Seal Cond: **Sound**

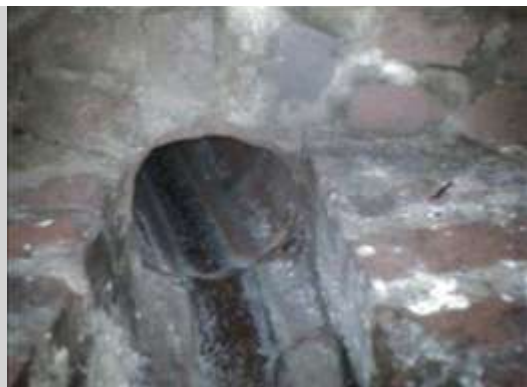
5 O'Clock Inflow

6 in. Circular Service Sewer  
Pipe In @ 5 O'Clock

Pipe Height: **6** (in.) Rod and Bar (Angled)  
Pipe Material: **Clay** ☐ Pipe Lined  
Invert Depth: **8.66** (ft.) Flow Characteristics: **Fast**  
Deposits: ☒ None ☐ Mud ☐ Sludge ☐ Debris ☐ Grease  
Silt Depth: (in.) Deposits Extent:  
Infiltration: **None** Pipe Seal Cond: **Sound**
